Movements of satellite-linked collared elephants and other wildlife in relation to the Standard Gauge Railway (SGR) and highways in Tsavo ecosystem, Kenya

(March – September 2016)

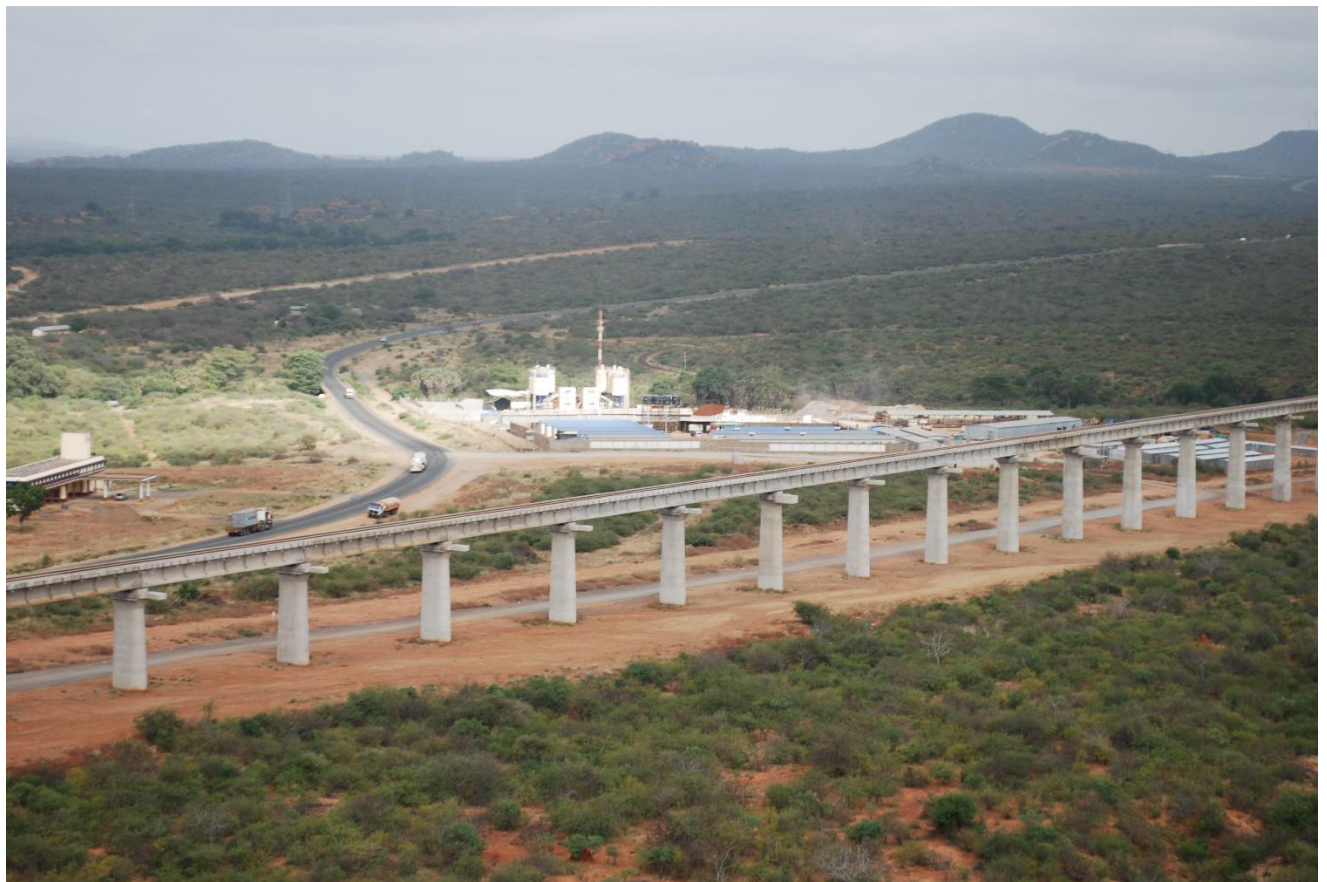
Cover photo: An aerial view of the Tsavo River super bridge along the SGR that could also be used by wildlife as an underpass. Next to it is the Mombasa - Nairobi highway. A wildlife overpass to allow animals to crossing the highway needs to be urgently considered. *Photo courtesy of Richard Moller of Tsavo Trust.*

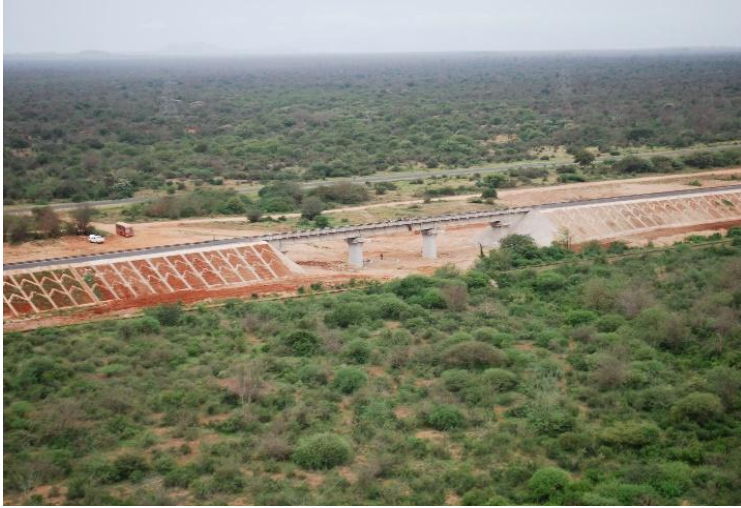
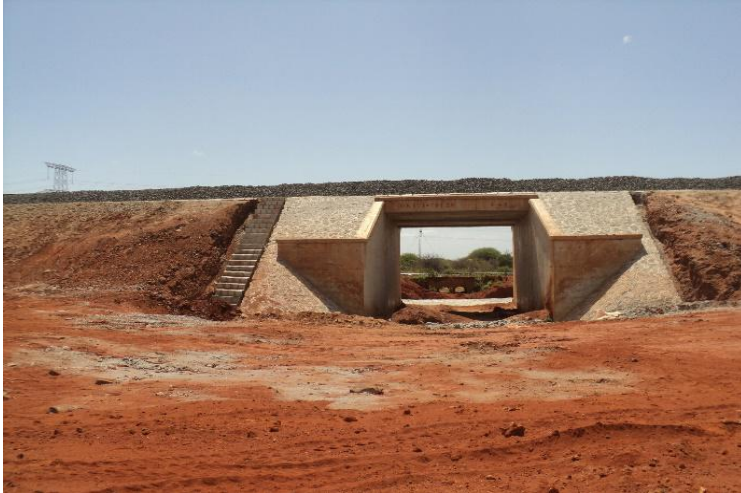
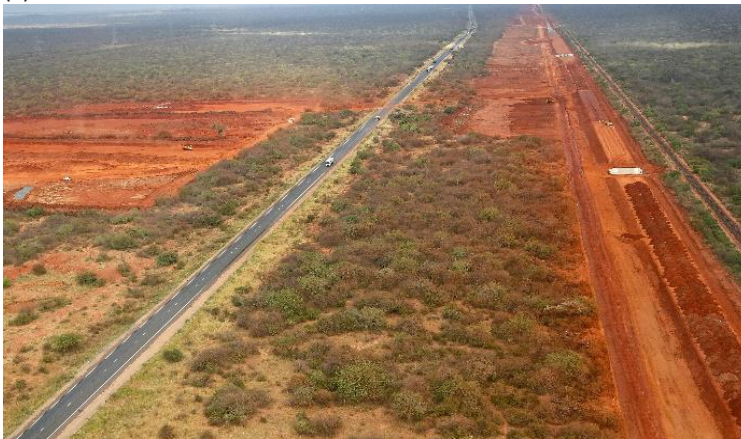
Plate 1: Example of (a) an underpass on an elevated railway, (b) a culvert which could be used as an underpass for elephants (c) an aerial view of locations of underpasses and culverts (white patch) along the SGR under construction. To the left of the SGR construction is the Mombasa–Nairobi highway and to the right is the old railway line.

It was feared that the SGR would cut the wildlife populations in two. However, the contractor of the SGR, the China Communications Construction Company Limited in collaboration with KWS, constructed six wildlife-crossing structures in the form of underpasses each measuring around 70 m long x 6 m high. The placement, design and sizes was guided by the long-term monitoring data and information generated by KWS. Other potential underpasses along the SGR are the 1,980 m long Tsavo River bridge, the 520 m long inter-crossing between the old railway and the new SGR at Kenani, and 30 drainages or culverts over seasonal dry riverbeds (luggas) that are greater than 5 m high and range from 6 m to 210 m long (Plate 1). Speed bumps and speed limit signage for wildlife-crossing have been provided at 4 sites along the Voi - Taveta highway.

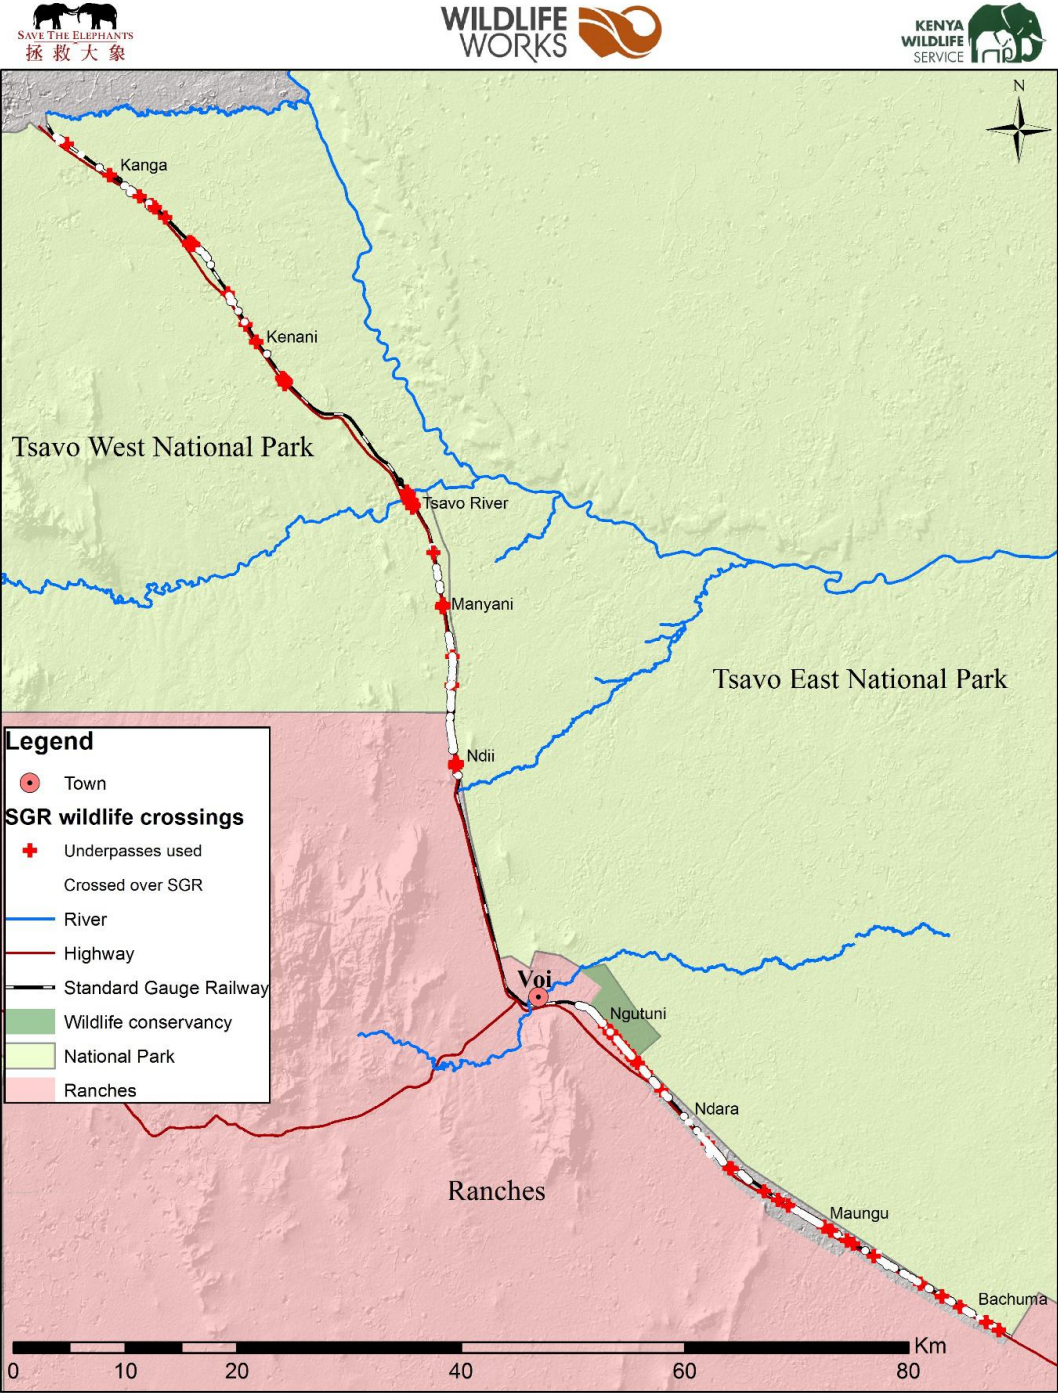
Figure 7: An overall map showing wildlife crossing points along the SGR from Bachuma to Mtito Andei. The red cross signs are areas where wildlife crossed the SGR using a designated underpass, a bridge or a culvert. The white dots are areas where wildlife species were recorded as having climbed over the SGR embankment.

Three times per week beginning 24th June 2016, one team from Wildlife Works and one team from KWS Voi HQ monitor the Voi - Bachuma (DK 140 to DK 90+360, approximately 50 km) and the Voi - Mito Andei (DK 144 to DK 239, approximately 95 km) sections respectively. This is done by driving an open vehicle with two observers or by riding on motorbikes slowly along the SGR service road for signs of animals that crossed the SGR. Double counting of the signs was minimized by marking the already recorded animal crossings using sawdust. As of October 2016, a total of 1,036 incidences were recorded of wildlife crossing the SGR by climbing over it or by walking through the designated underpasses and culverts. Seven hundred and sixty eight (768) crossings were made by elephants. These comprised 74% of the total incidences of animal crossings. This suggests that elephants are the species most affected by the SGR, or could be an indication that elephants are not bothered by it as they crossed, but other wildlife species were prevented from trying to cross. The individual points of wildlife crossings during

this monitoring period are shown in Figure 7. The game-proof SGR fence will prevent these movements over the SGR where there is no underpass and therefore culverts should be unfenced to allow movement.

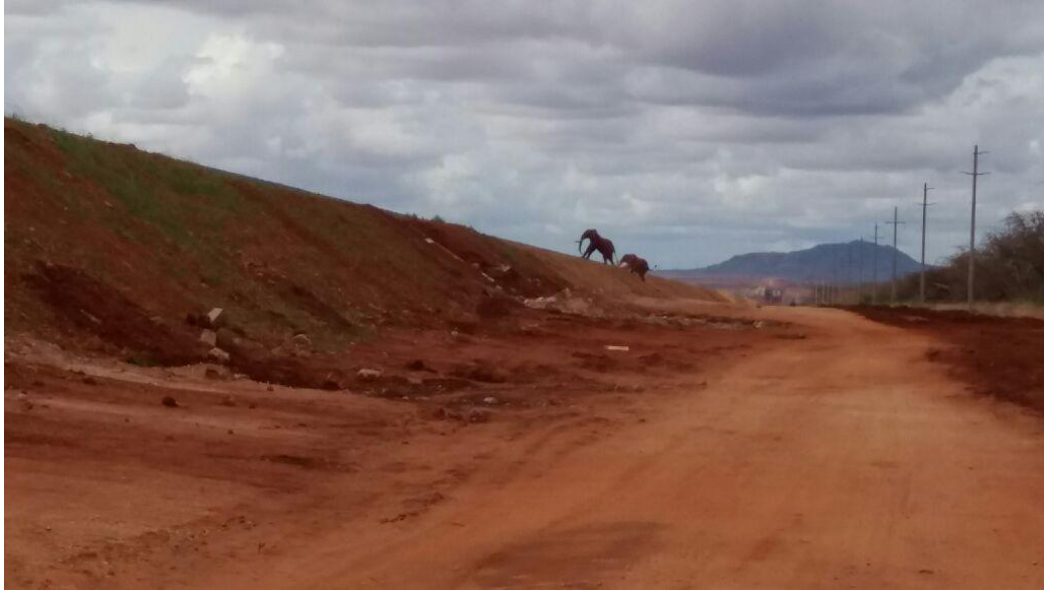
Plate 2: A photograph of elephants climbing over the SGR embankment (above) and below is a photograph of elephant footprints (circled by dotted lines) crossing the SGR at another location

The 135 km section that bisects the Tsavo Ecosystem will imminently be fenced and closed on either side of the railway embankment to ensure passengers' safety by minimizing the likelihood of trains hitting animals climbing over the SGR. Elephants climbing over the SGR will inevitably occur (see Plate 2) unless an effective and well-maintained elephant-proof fence is erected parallel to the SGR. The type and design of the fence is therefore of utmost importance. Unfortunately, the fence that was being constructed during the period of this study to keep wildlife from approaching the railway tracks was in no way elephant-proof, because it lacked power and use of chain-link that is prohibited in a game proof fence. It had been trampled down by passing elephants within one month of construction of some sections (See Plate 4). If an SGR train hits an elephant at 120 km/hr the consequences would be dire for passengers, train and elephant. More so, vandalization of a chain-link fence is more likely than of electric fence and could potentially be used as wire snares for smaller wildlife species. The only way of avoiding a potential catastrophe, we believe, is to construct a full electrified elephant-proof fence and as

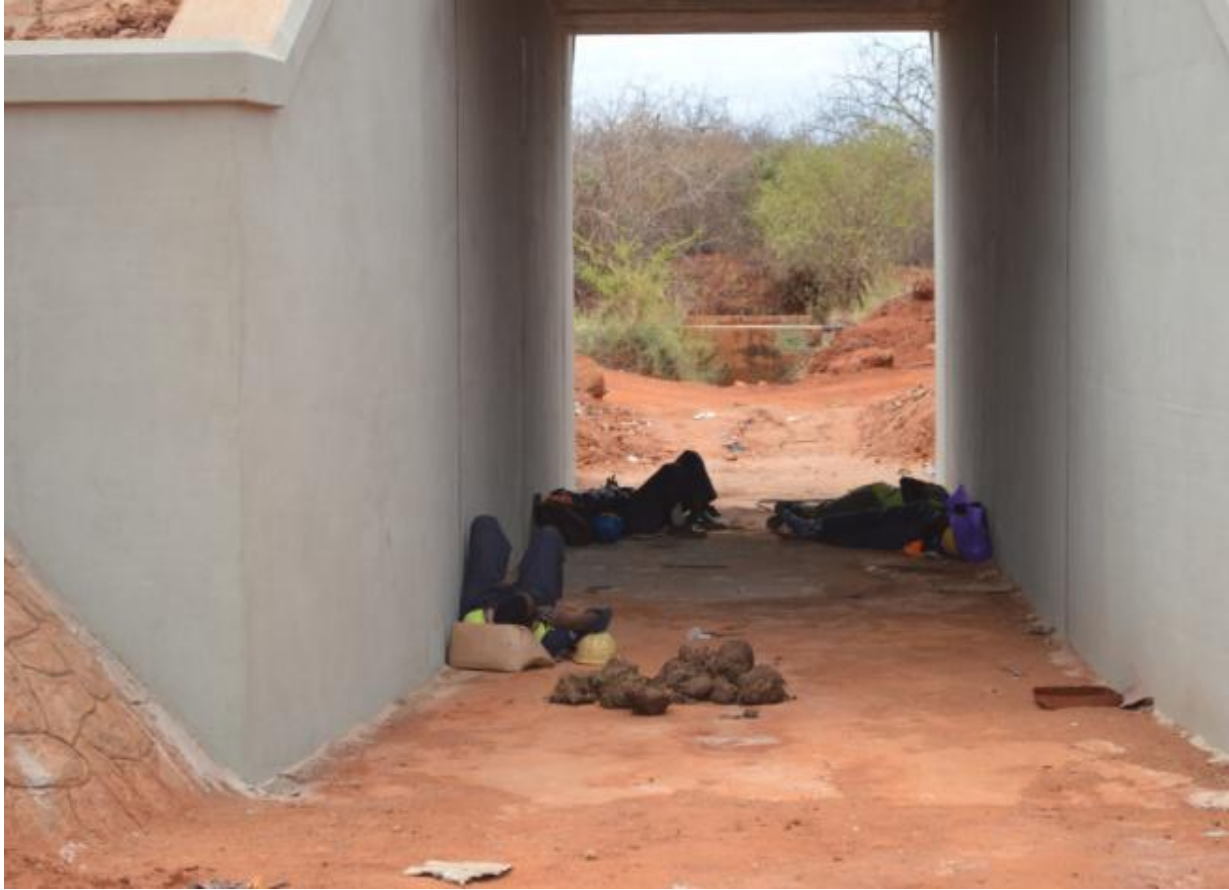
Plate 3: Elephant dung as evidence of utilization of drainage culverts along the SGR.

It was evident that apart from the six underpasses purposely constructed for the wildlife crossings and dispersal, other potential faunal passages such as bridges for water flows, old railway/SGR crossing points and drainage culverts were utilized by wildlife for their dispersal (See Plate 3). There were many attempts by elephants to climb up the steep SGR embankments with 598 incidences of successful climbs over the SGR and slides down the other side.

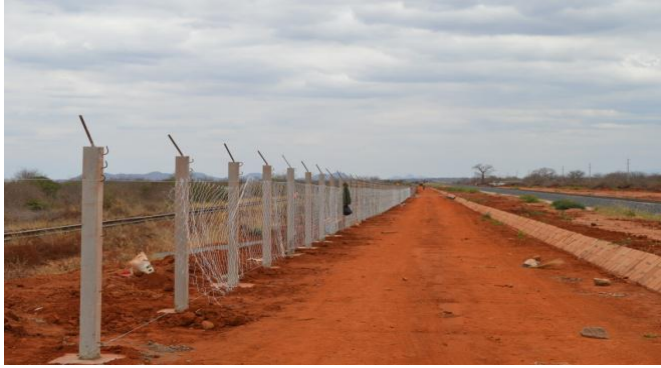
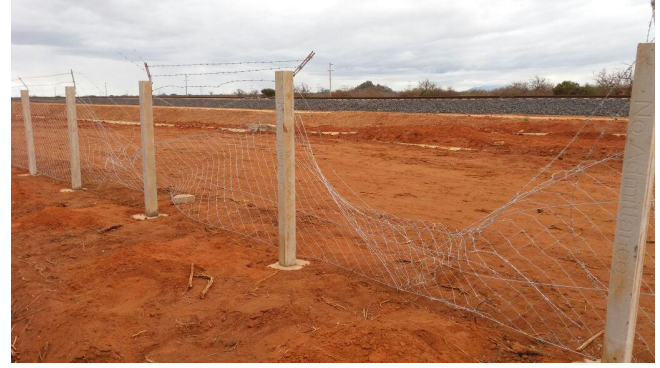
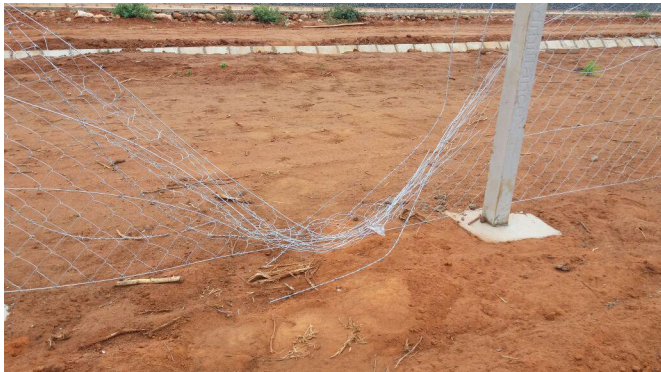
Plate 4: The SGR fence as constructed by the SGR contractors between March and September 2016 to prevent wildlife from crossing over the SGR embankment. Sections where elephants have trampled down the fence are shown. The structural design of this fence, courtesy of the SGR contractors, is also shown below.

such, KWS stopped the contractor from continuing with the construction of the chain-link fence in August 2016. Effective designs such as that one shown in Plate 5a that was proposed by KWS and submitted to the SGR contractors are already available and up and running in many parts of Kenya. We are pleased to report here that construction of a 200 m trial electric elephant-proof fence around Manyani area began in October 2016, and awaits approval from KWS (Plate 5b).
