# The effect of the new standard gauge railway (SGR) on elephant movements in Tsavo Ecosystem, Kenya (March 2016 – March 2018)

**About this report:** This report is an update of the 6-month and 1 year reports produced in October 2016 and July 2017 respectively. It documents findings made between March 2016 and March 2018 of 10 collared elephants in relation to the SGR and highway in Tsavo, and also observations before and after SGR completion on elephant utilization of underpasses. The findings are illustrated using maps, graphs, tables and photos.

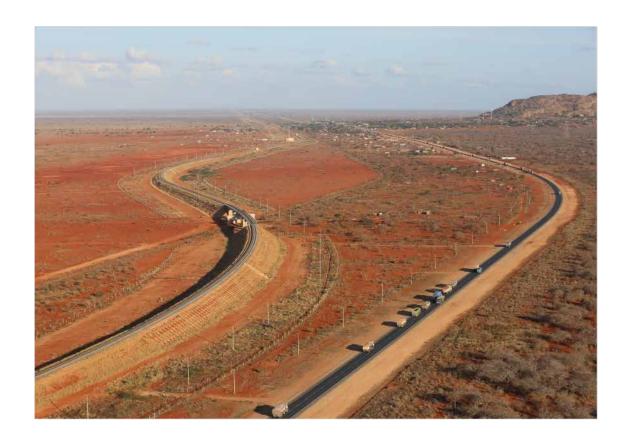
**Cover photo:** The standard gauge railway and Maungu rail crossing bridge; an underpass utilized by elephants to cross the SGR but is being encroached by human settlement (Photo credit: Richard Moller, Tsavo Trust)

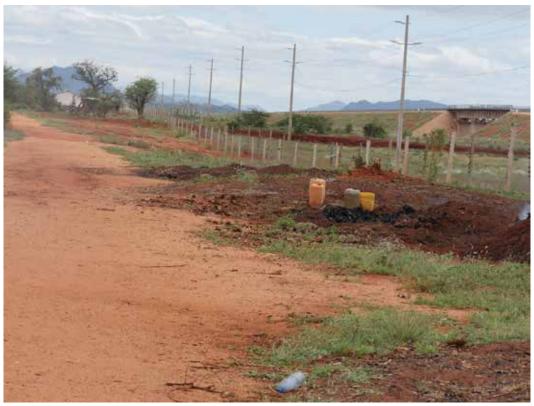
Plate 1: Illegal human settlement and charcoal kiln near Ndara corridor underpass at DK125

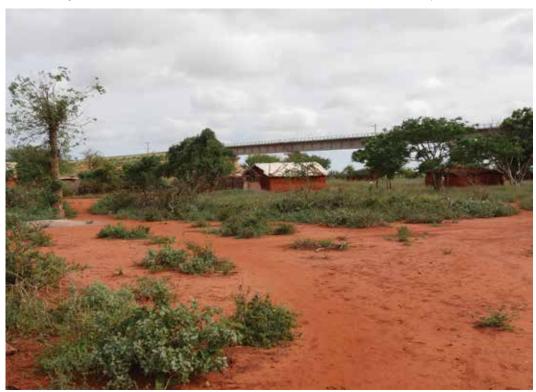
**Plate 2:** Illegal human settlement at Maungu rail crossing bridge at DK118, which is utilized by wildlife
